UNITED STATES AIR FORCE
AIRCRAFT ACCIDENT INVESTIGATION
BOARD REPORT

C-17A, T/N 00-0173

JOINT BASE ELMENDORF-RICHARDSON, ALASKA

DATE OF ACCIDENT: 28 JULY 2010

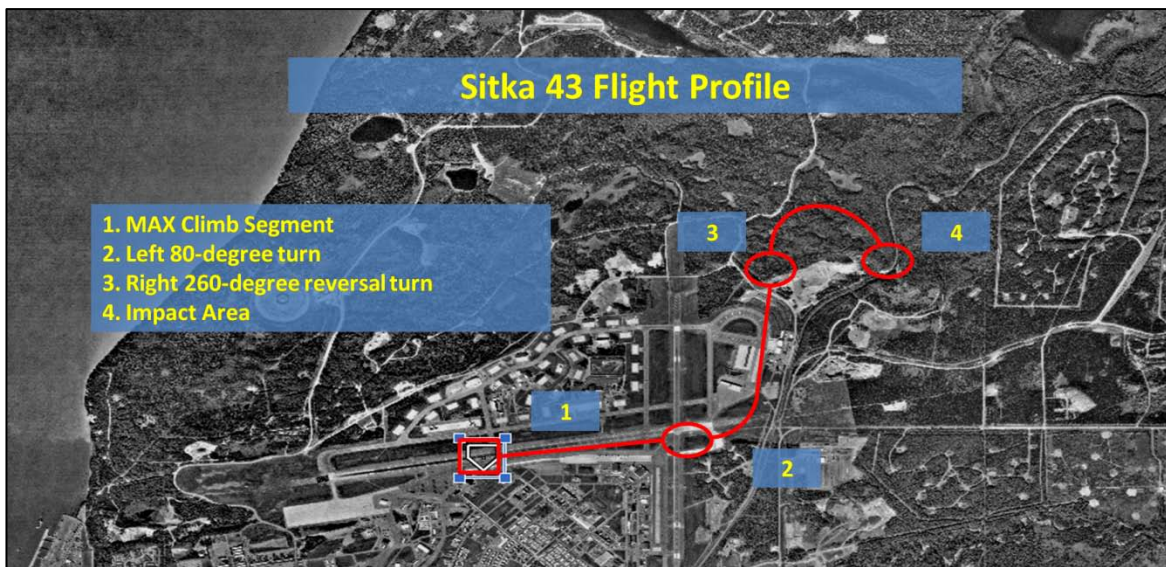
Approximately 62 seconds into the mishap sortie, the MA stalled. By this time, the deep stall protection system (the Angle of Attack Limiter System (ALS)) was active, but was overcome by the MP's rapid and aggressive maneuvers. (Tabs L-3, BB-3, CC-3 through CC-27) Within seconds, the MA's bank angle increased to a maximum of 82 degrees. The aircraft began to descend and ultimately reached a descent rate of 9,000 feet per minute, as airspeed decayed to 184 kts. (Tabs L-3, CC-3 through CC-27, CC-60 through CC-68, DD-21)

One-and-a-half seconds into the stall, several events occurred simultaneously: the MCP said "not so tight, brother"; the MSO said "watch your bank" three times; and the MP moved the control stick full left, applied left rudder, but maintained constant control stick pressure. (Tabs L-3, N-18, CC-3 through CC-27)

Five seconds prior to impact, the slats fully retracted. Approximately two seconds prior to impact, the MP was able to initiate a left roll of the aircraft, however, the roll rate was minimal due to the stall. (Tab L-3, CC-3 through CC-27) The stall protection system remained active until impact.
